**Monthly Progress Report**

# July 2019

#### 9. Progress Photographs

Monthly Report No. 16

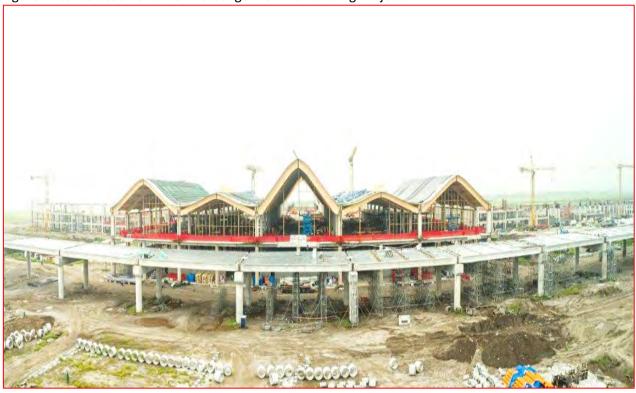
Figure 1: Construction of a New Passenger Teminal Building Project.

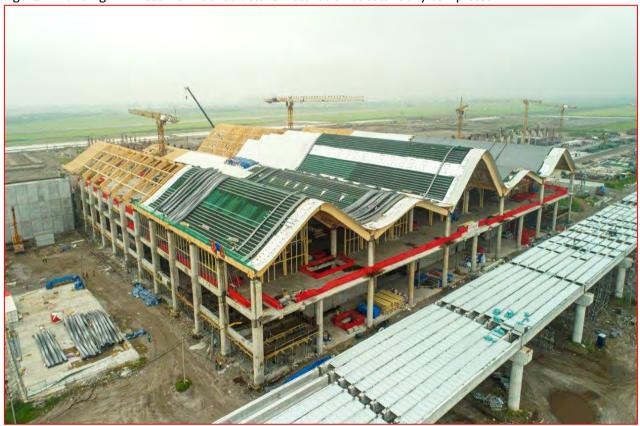
Figure 2: Building 1 – West Pier Roof Structure installation substantially completed.

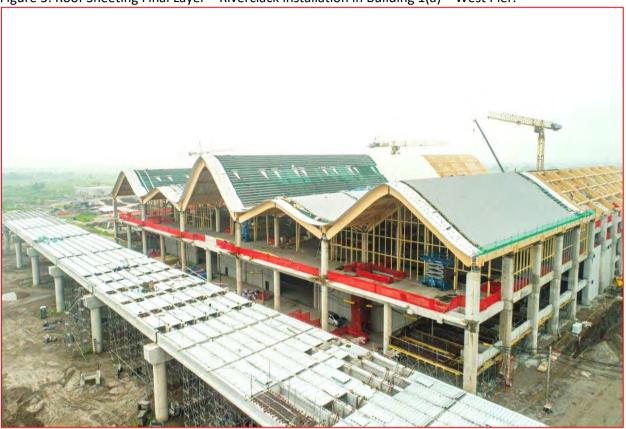
Figure 3: Roof Sheeting Final Layer – Riverclack installation in Building 1(a) – West Pier.

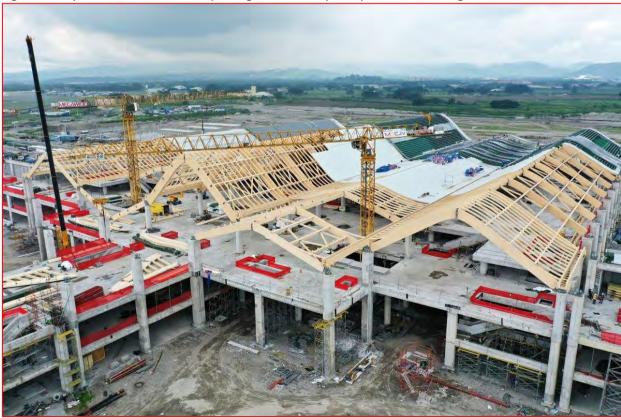
Figure 4: Departure Level concrete placing substantially completed in Building 1.

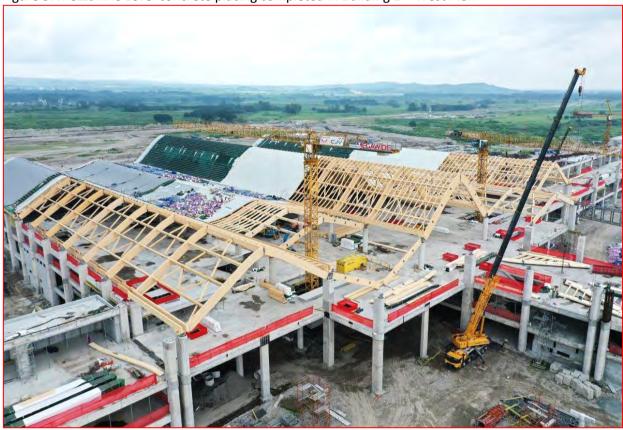
Figure 5: Mezzanine Level concrete placing completed in Building 1 – West Pier.

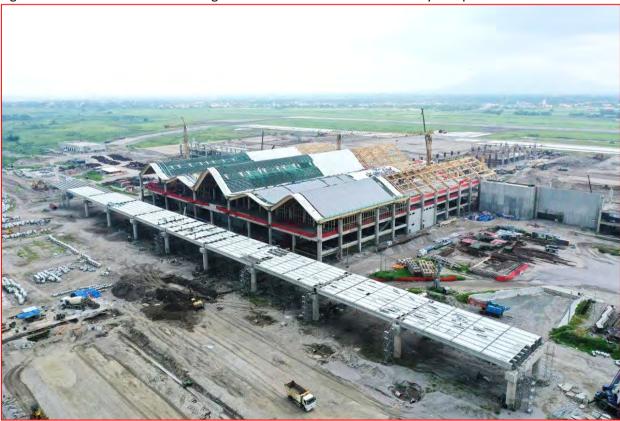
Figure 6: Installation of steel decking and Girder installation substantially completed in Elevated Road.

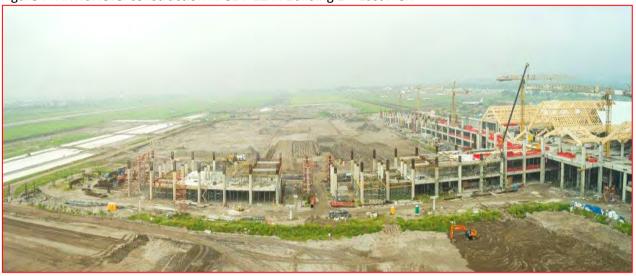
Figure 7: Arrival level construction in GL 7-12 in Building 2 – East Pier.

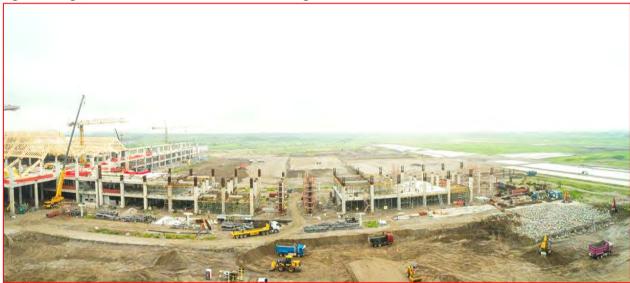
Figure 8: High/Roof column construction in Building 2 – East Pier.

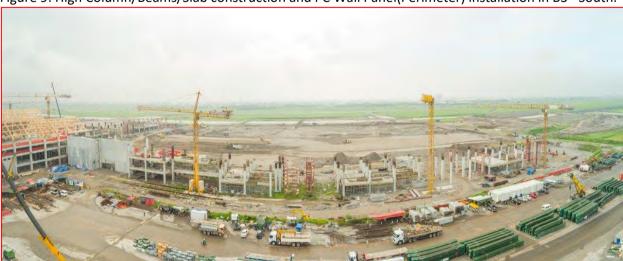
Figure 9: High Column/Beams/Slab construction and PC Wall Panel(Perimeter) installation in B3– South.

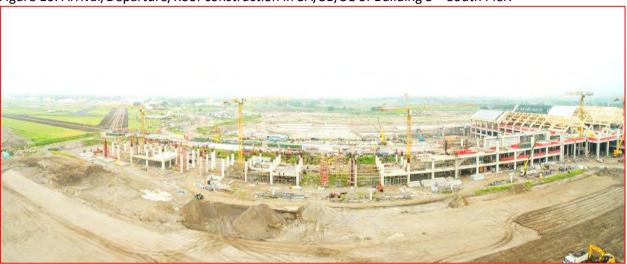
Figure 10: Arrival/Departure/Roof construction in 3A/3B/3C of Building 3 – South Pier.

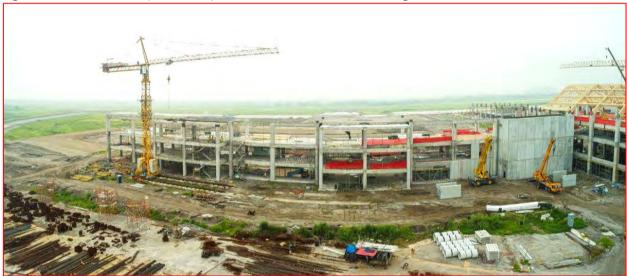
Figure 11: PC Wall Panel(Perimeter) and CMU installation in Building 4 – North Pier.

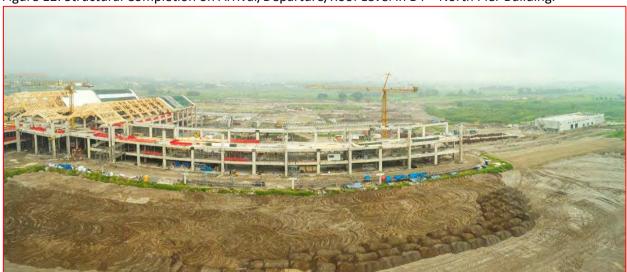
Figure 12: Structural Completion on Arrival/Departure/Roof Level in B4 – North Pier Building.

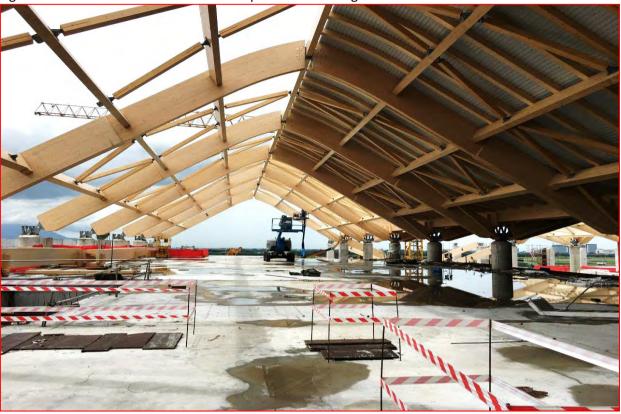
Figure 13: Mezzanine Level structural completion in Building 1.

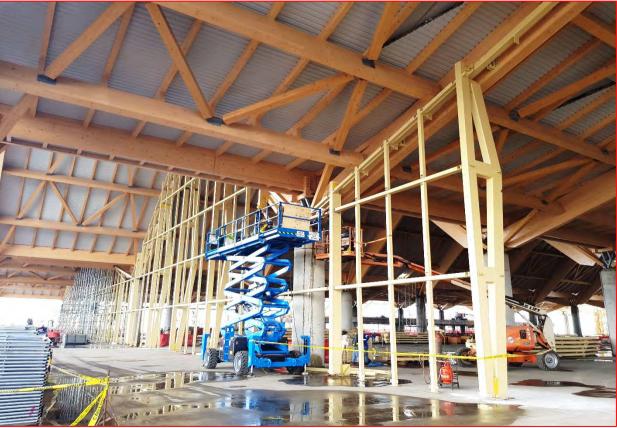
Figure 14: Façade Steel installation in GL 42 in Building 1 – West Pier.

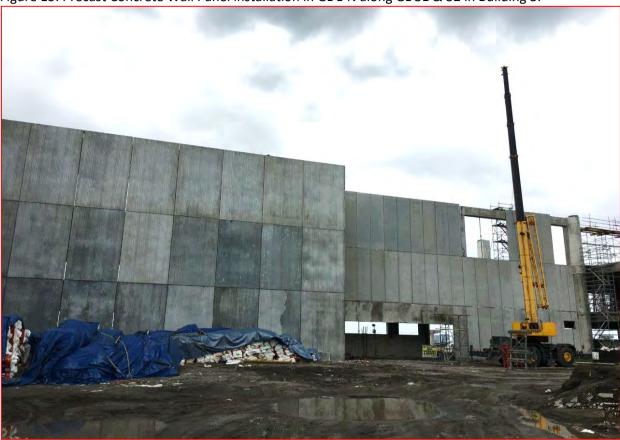
Figure 15: Precast Concrete Wall Panel installation in GL L-N along GL 31 & 32 in Building 3.

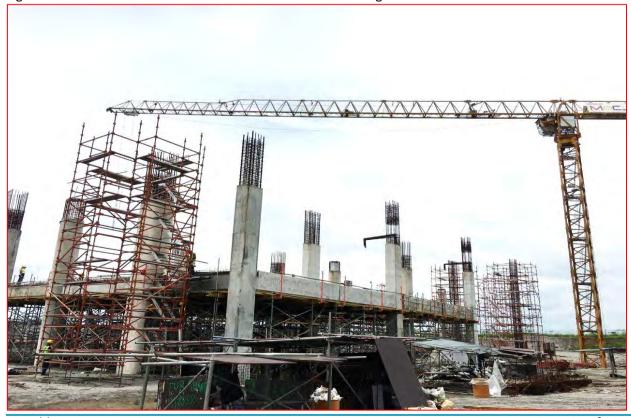
Figure 16: Arrival Level Beams and Slab construction in Building 3C – South Pier.

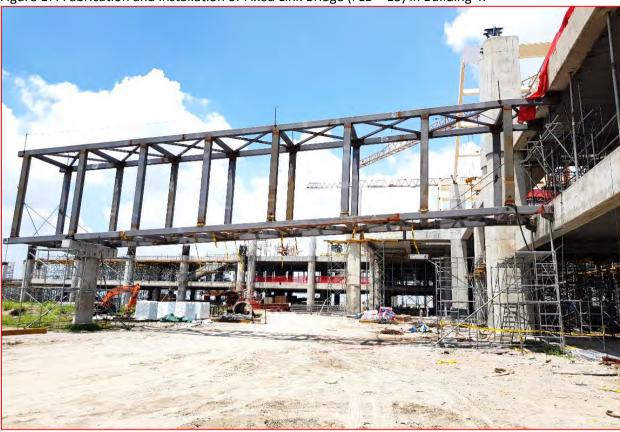
Figure 17: Fabrication and installation of Fixed Link Bridge (FLB – 13) in Building 4.

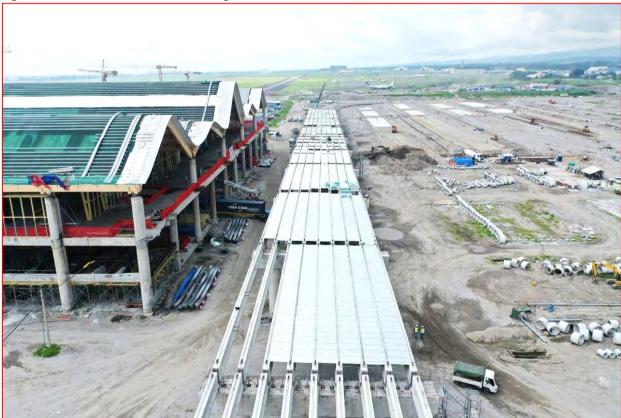
Figure 18: Elevated Road steel decking installation and corbel construction.

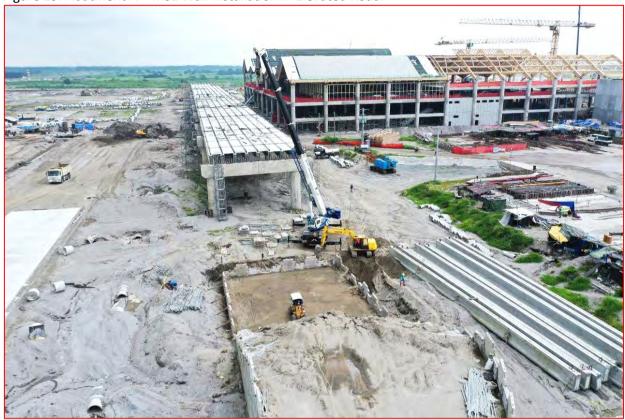
Figure 19: Abutment A – MSE Wall installation in Elevated Road.

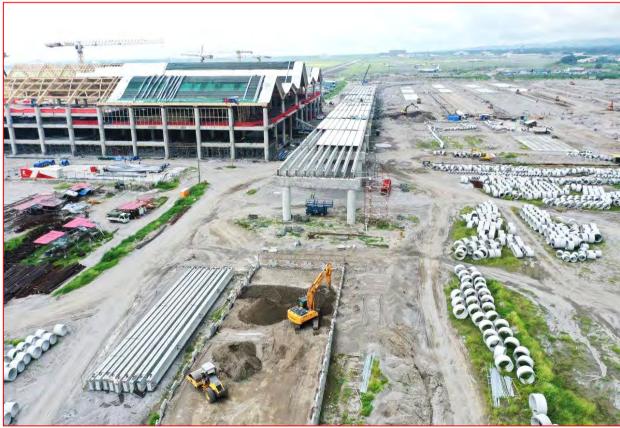
Figure 20: Abutment B – MSE Wall installation in Elevated Road.

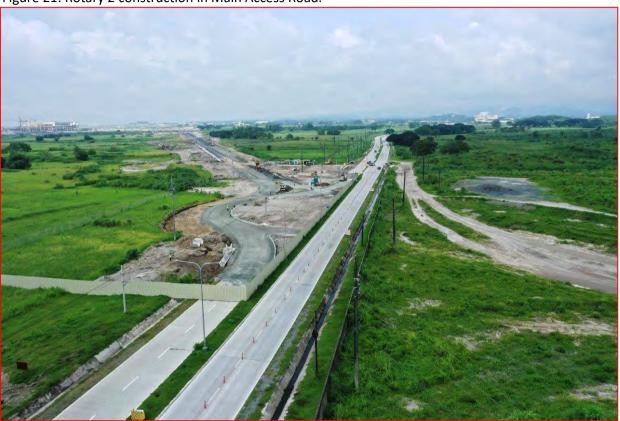
Figure 21: Rotary 2 construction in Main Access Road.

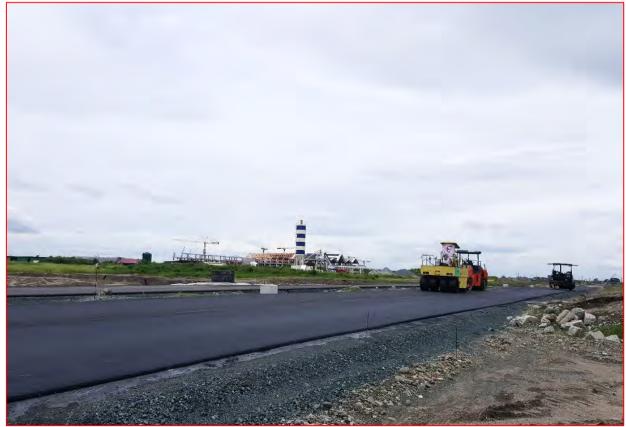
Figure 22: Asphalt laying and compaction in Main Access Road.

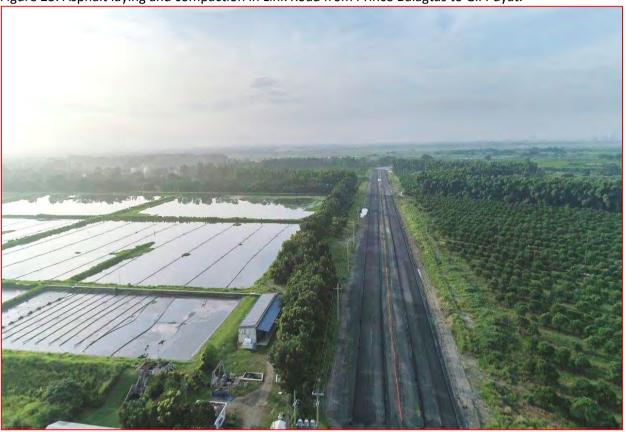
Figure 23: Asphalt laying and compaction in Link Road from Prince Balagtas to Gil Puyat.

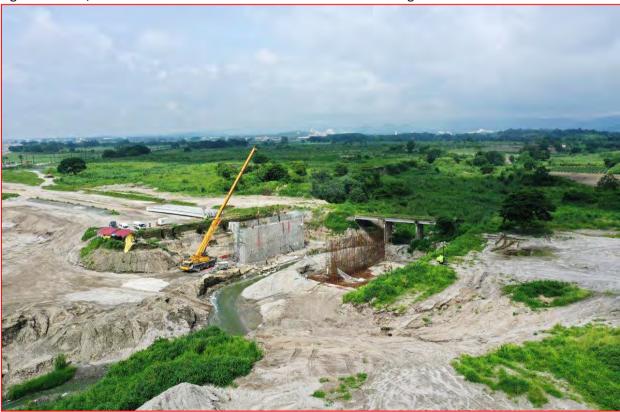
Figure 24: Civil/ Structural Substructure Construction of Dolores Bridge

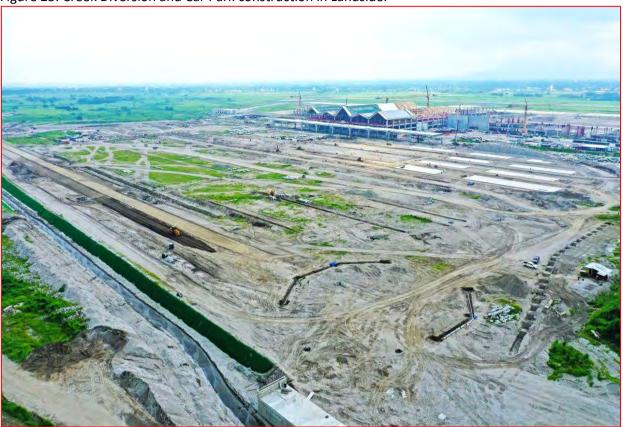
Figure 25: Creek Diversion and Car Park construction in Landside.

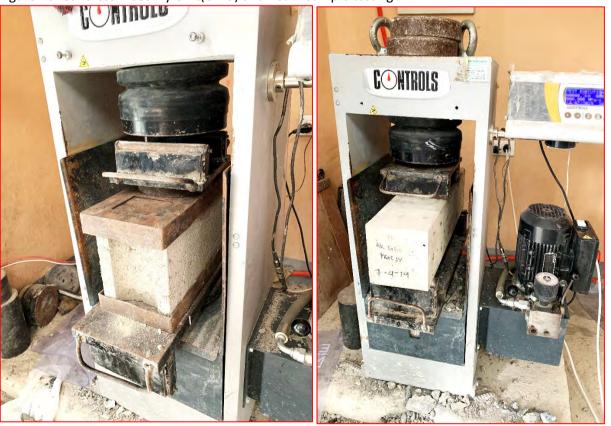
Figure 26: Concrete Masonry Unit(CMU) and Beam Sample testing.
